NATIONAL PROGRAM FOR INSPECTION OF NON-FEDERAL DAMS  
GALE MEADOWS DAM (VT (U) CORPS OF ENGINEERS WALTHAM MA  
NEW ENGLAND DIV MAR 80

GAIA MEADOWS DAM VT 00115

MAR 1980

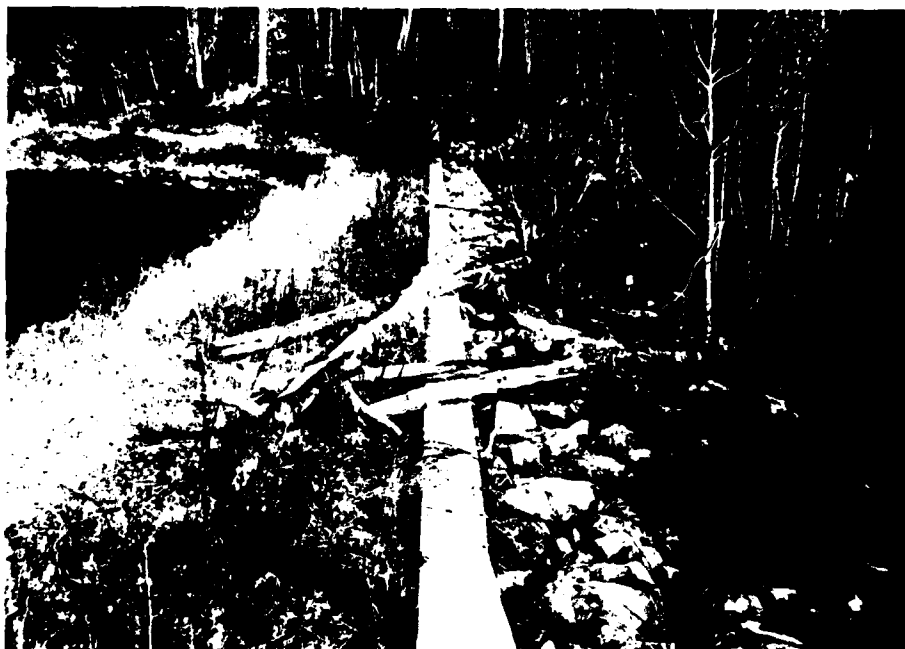
C-9A Emergency spillway weir control section looking toward left abutment - 11/19/79
